MATERIALS TECHNOLOGY FOR COAL-CONVERSION PROCESSES

**Thirteenth Quarterly Report,
January—March 1978**

ANL-78-54

Task F -- Component Performance and Failure Analysis (S. Danyluk, G.M. Dragel, W.J. Shack, and J.Y. Park)

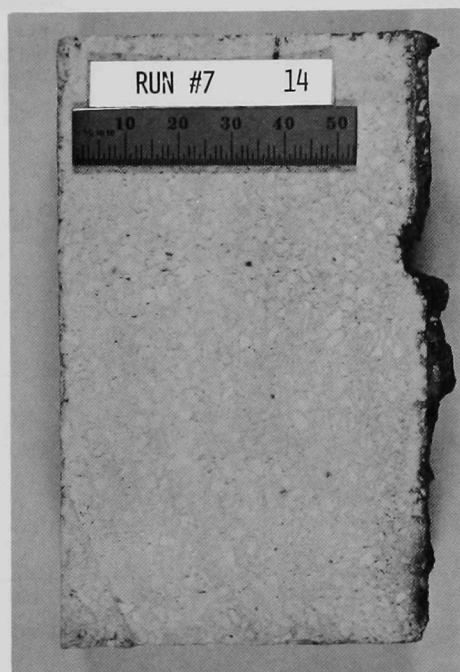
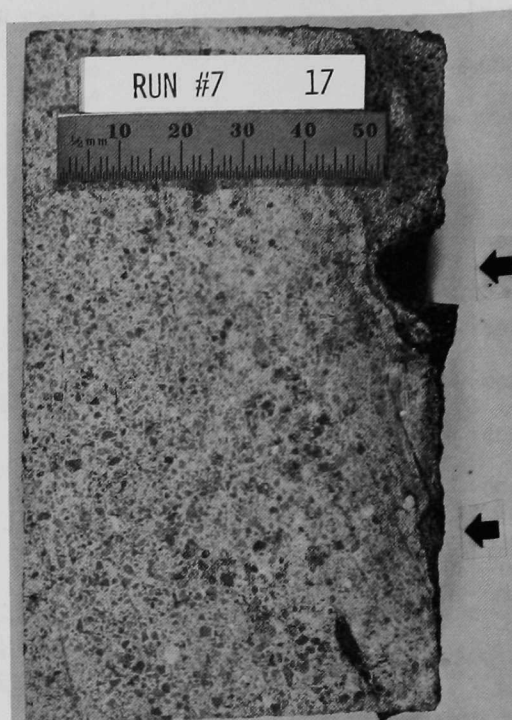
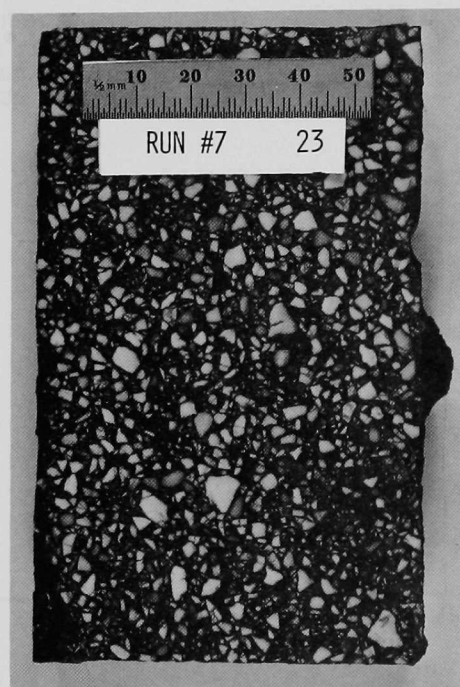
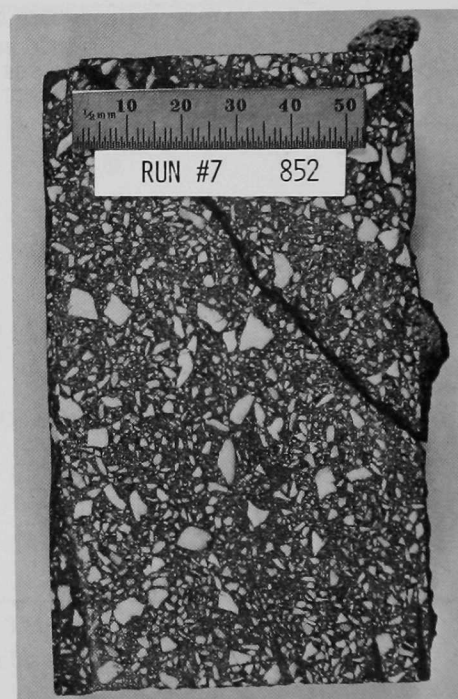
Fig. 3. Cut Sections of the 3/4-length Refractories Exposed to Slag Attack in Run 7. (a) Alumina-silica (Number 14), (b) alumina-silica (Number 17), (c) alumina-chromia (Number 23), and (d) alumina-chromia (Number 852). The vertical face on the right-hand side of each brick was exposed to the slag. Two lines of slag attack [see arrows in (b)] are visible on brick number 17.

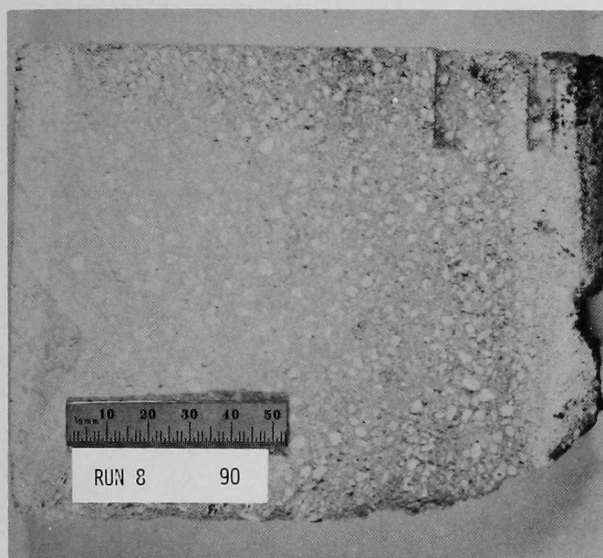
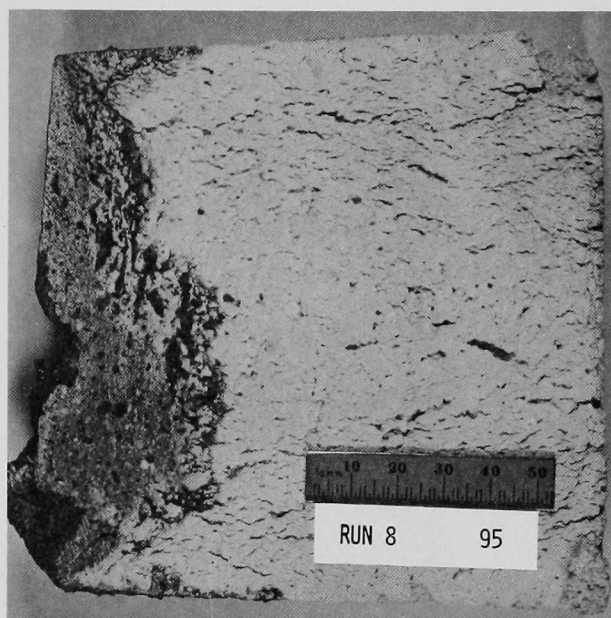
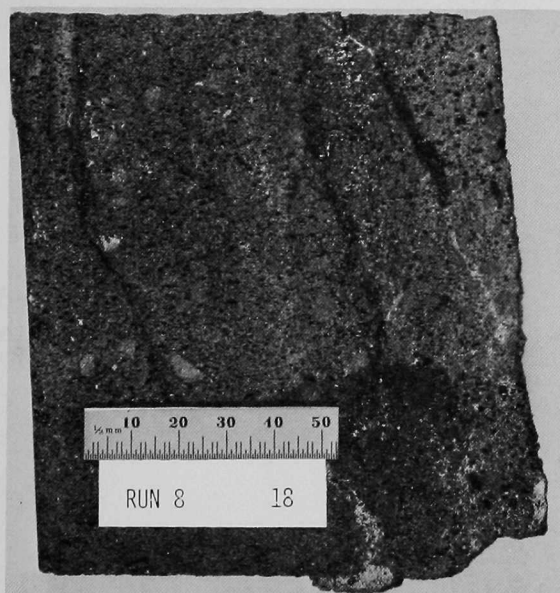
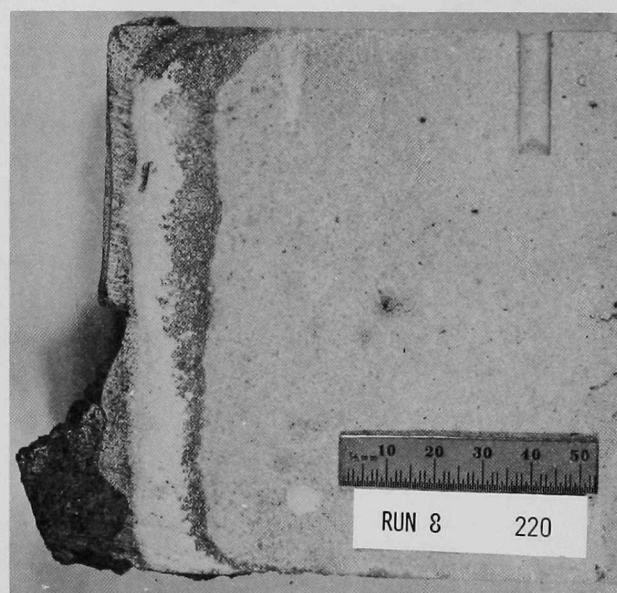
Fig. 8. Cut Sections of the Full-length Refractories Exposed to Slag Attack in Test Run 8. (a) Number 90 (bottom slag-attack zone is broken off), (b) Number 95, (c) Number 18 (bottom slag-attack zone is broken off), and (d) Number 220. The vertical faces toward the center of the page were exposed to two levels of slag.

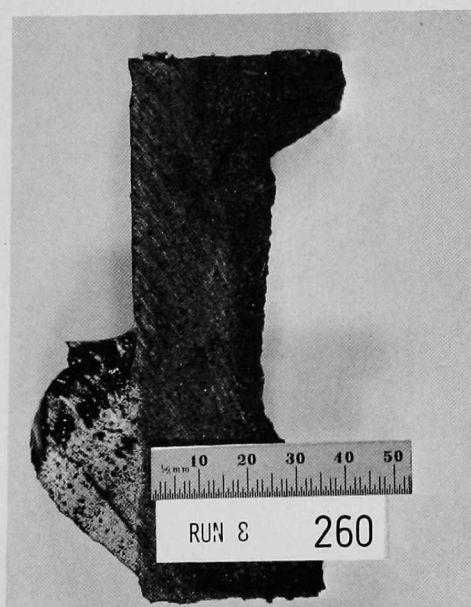
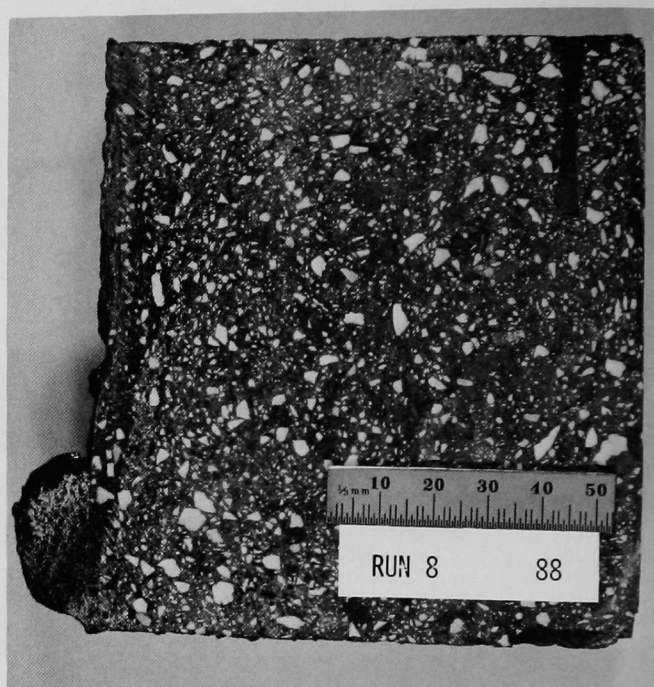
Fig. 9. Cut Sections of Refractories Exposed to Slag Attack in Test Run 8.
 (a) Number 260 and (b) Number 88. The left-hand vertical face was exposed.
 Note that number 260 fractured ~ 20 mm from the hot face (the cooler section of the brick is not shown).

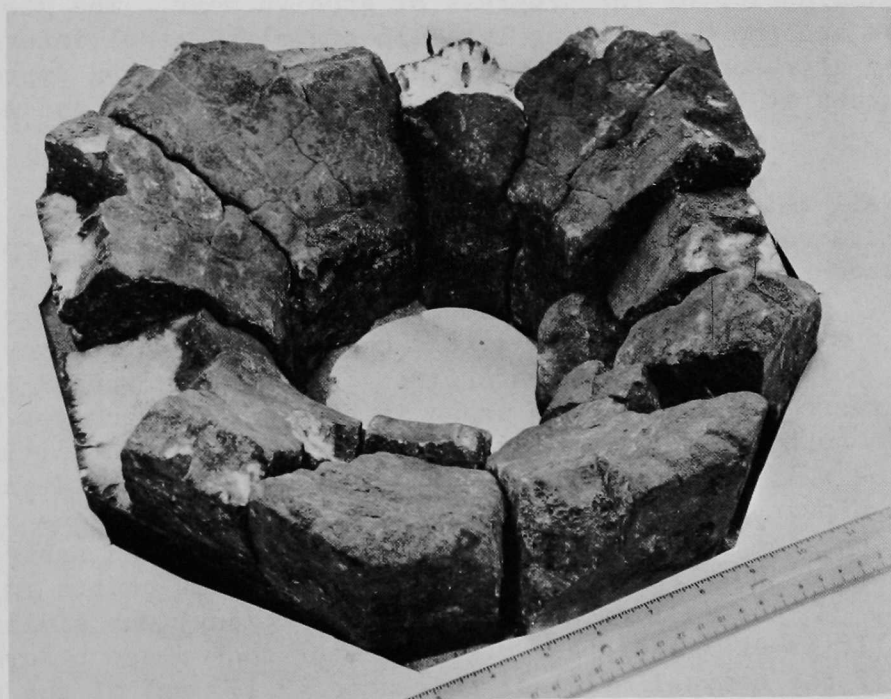
Fig. 11. Slag Outlet Block Obtained from Bi-Gas Pilot Plant, Homer City, PA.

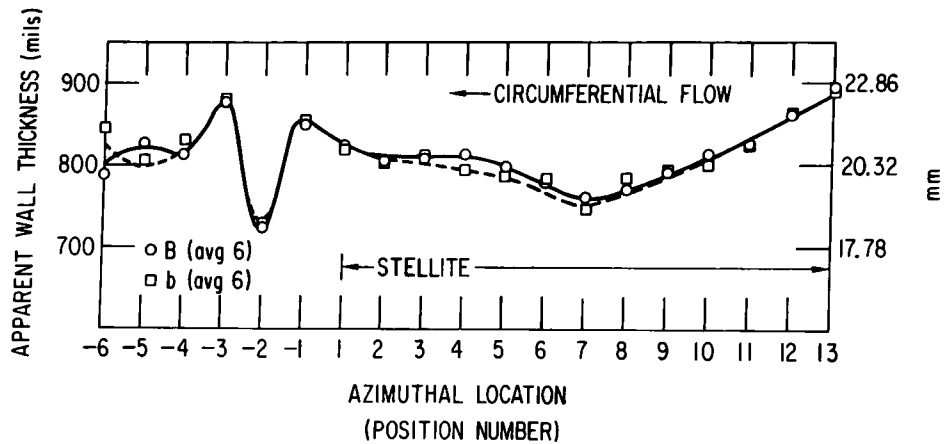
Wall thicknesses in the stellite-lined region of the cyclone were measured ultrasonically with a 5-MHz, 1/2-in. diameter Aerotech gamma transducer, Apiezon-L couplant, and Branson 303B pulser-receiver equipped with a time-analog gate. The measuring sites were the same as those previously monitored, defined by a matrix plate welded to the outer surface of the cyclone. Results of an azimuthal scan near the centerline of the matrix, which includes the matrix points of greatest thinning, are shown in Fig. 12. The curves were produced by smoothing in both the axial and azimuthal directions. An initial lack of concentricity as well as subsequent erosive wear produced the depression in the curve between points 5 and 9. The apparent wear in this zone since the first inspection, obtained by averaging these 3142-h points and subtracting the result from the average 300-h thickness measured at the same points in December, 1975, was 1.59 mm. The overall rate of wear (0.013 mm/day) was similar to that given in Ref. 2. It is estimated that 0.168 mm wear took place before the first inspection. If the nominal original thickness (3.175 mm) of the stellite lining was correct for the region defined by points 5-9, about 55% of the stellite has been eroded from that area.

An axial groove has developed at azimuthal position -2 of the cyclone, situated just past the end of the stellite-lined surface (Fig. 12). The material of the cyclone body is Type 304 stainless steel in the form of 8-in. schedule-160 pipe (original wall thickness 23 mm). Typically the inlet gas velocity is 15 m/s with a 1.8 kg/m^3 loading of 10-60- μm (about half) and 70-150- μm particles, according to IGT personnel. (Particle size was determined from samples recovered after discharge to slurry.) The groove was previously reported in Ref. 5 but has now become the site of minimum wall thickness in the inlet region. Inasmuch as the cyclone operates at 6.9 MPa and 316°C, subsequent monitoring of this zone may become important in terms of safety as well as material economics.

Fig. 12. HYGAS Cyclone Separator after 3142 Operating Hours. Wall thickness at matrix rows B and b versus azimuthal location, 3/78. Neg. No. MSD 65256

The foregoing results were reported to responsible personnel at the HYGAS plant. They have tentatively concluded that operation of the cyclone can be resumed but preparation of a replacement cyclone should be considered.

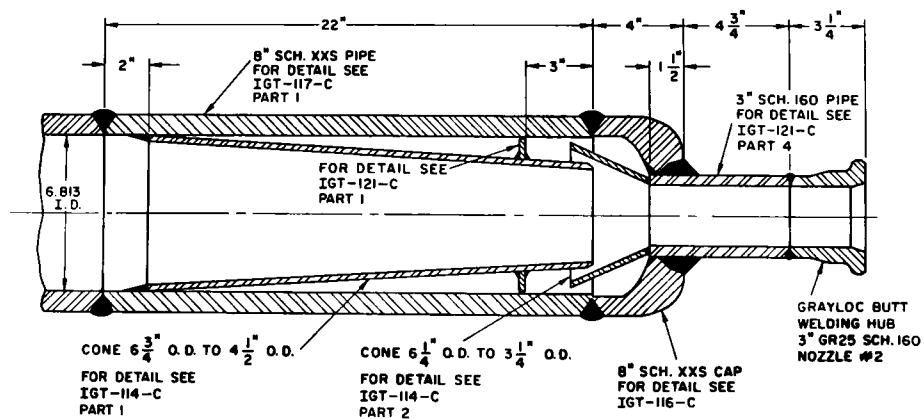
A substantial amount of erosion of the 0.51-m-long cone structure within the cyclone has occurred. The location of the Type 316 stainless steel cone in the assembly is shown in Fig. 13. The erosion process has produced a large-scale sawtooth ridge pattern on the inner surface of the long cone, with the ridges running generally in the axial direction and spaced 20-25° apart azimuthally. Ridge edges were irregular, as shown in an X-ray view exposed through the entire assembly and reproduced in Fig. 14. A schematic sketch of an end view of the sawtooth structure is shown in Fig. 15 together with thickness data based on a small number of determinations made ultrasonically with a 25-MHz Aerotech 1/4-in.-diameter alpha transducer fitted with a delay line, attached to a probe, and inserted to a depth of 0.5 m into the cyclone from the solids outlet flange. The limited data suggest that as much as 40% of the original 6.35-mm thickness of the cone has been eroded away.

Fig. 13. Section of HYGAS Cyclone Separator Showing Location of 0.51-m-long Cone. Solids outlet neck is at right. Drawing provided by Institute of Gas Technology. Neg. No. ANL-306-78-561

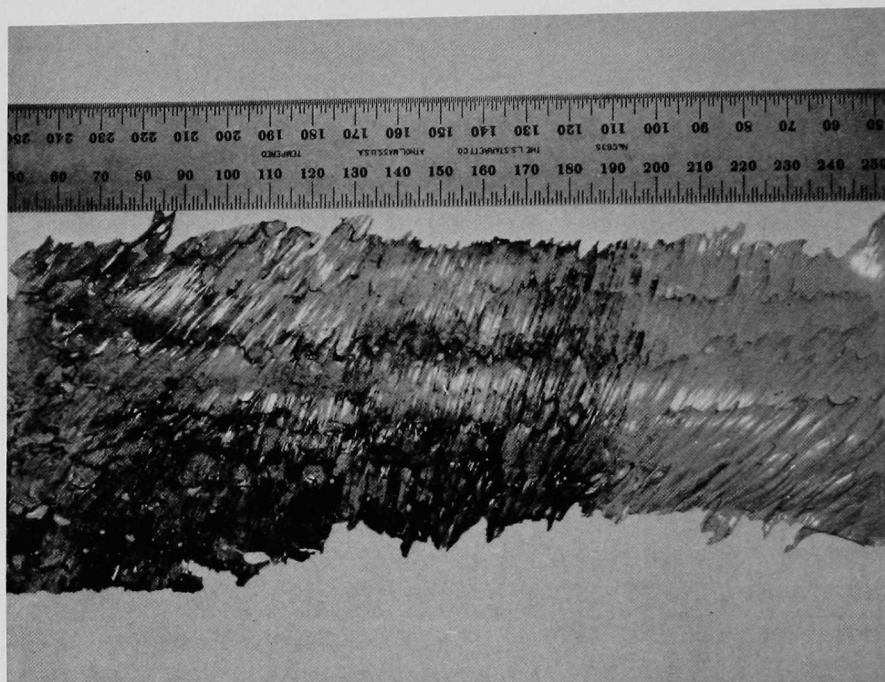
Considerable erosion of a stainless steel solids outlet liner that had been added to the cyclone since the last examination was evident, and a molded replica was made of the erosion pattern. A photo of the replica is given in Fig. 16. A longitudinal sawtooth pattern similar to that seen in the long cone section (Fig. 15) was present, superimposed on the helical grooves. The peak-to-valley distances on the replica were typically $\sim 1 \text{ mm}$, with some as large as 2.5 mm.

Fig. 16. Rubber Impression of Eroded Inner Surface of Liner in Solids Outlet Neck of HYGAS Cyclone Separator. Long dimension corresponds to axial direction and width includes a portion of the azimuthal surface, with outlet flange at right. Small divisions of ruler are millimeters. Neg. No. ANL-306-78-566

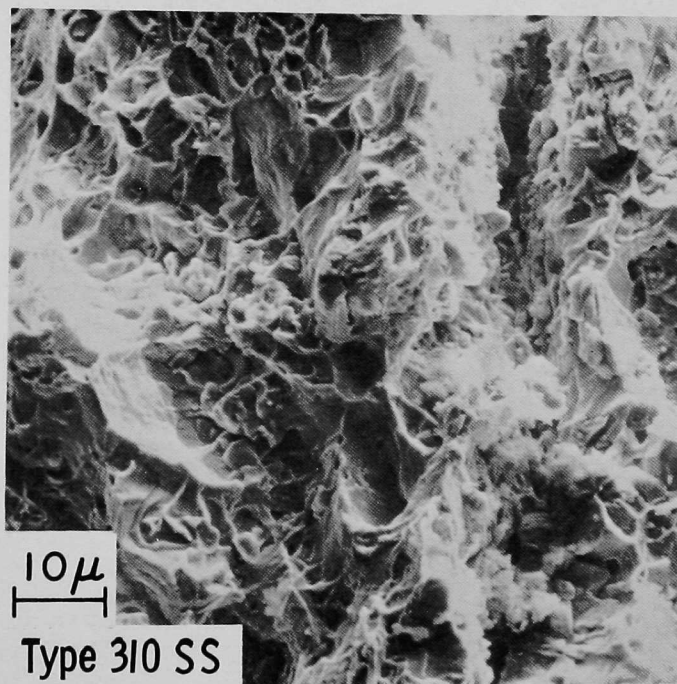
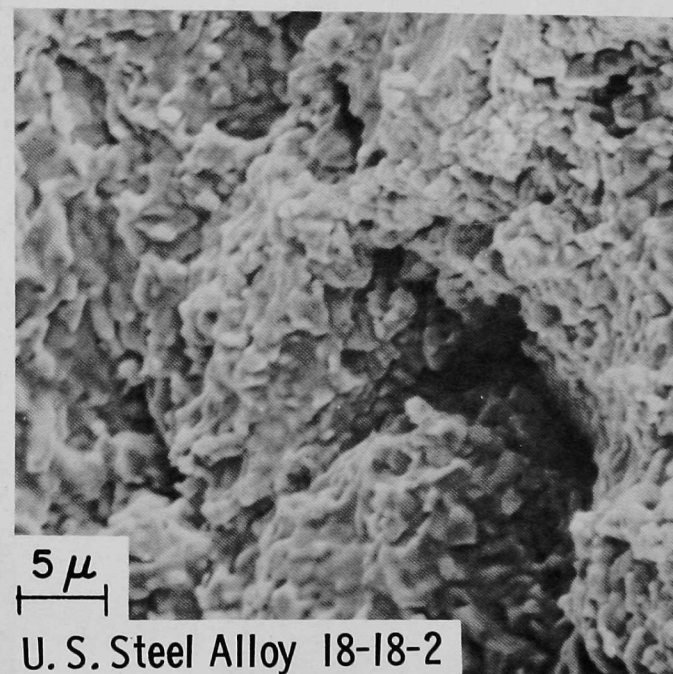
Fig. 45. SEM Photographs of Fracture Surfaces of Type 310 Stainless Steel and U.S. Steel Alloy 18-18-2 After a 1000-h Exposure to a Complex Gas Mixture at 750°C (Run A01A750). Neg. No. ANL-306-78-336

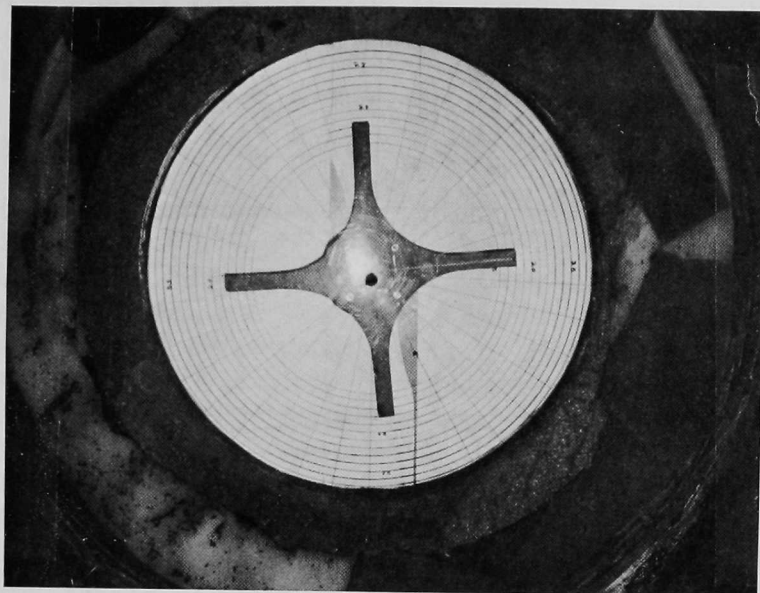
Fig. 46. Erosion-test Apparatus, Assembled with a Transparent Plexiglass Coverplate for Calibration

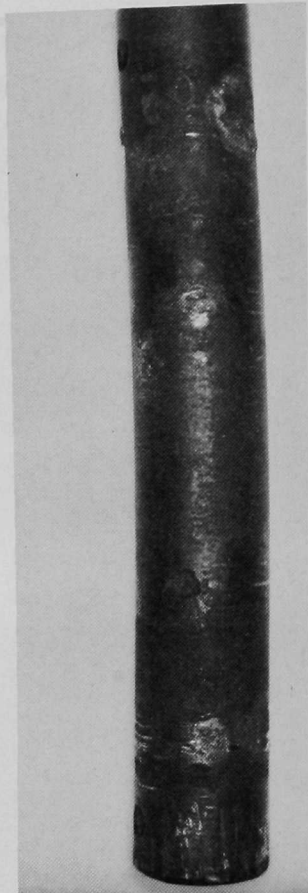
1.8 cm

A photograph of the as-received pin is shown in Fig. 55. The diameter is out of round and the pin is bent. Additional photographs of surface pitting and galling are shown in Fig. 56. Considerable damage is evident at the hinge end. The pit depth and galling are also shown in Fig. 57. The galled regions were shiny; this indicates that the pits formed prior to the galling. Grain-boundary penetration (most probably by sulfides) and internal corrosion were also found; these results are shown in Fig. 58. A heavy corrosion scale is seen at the OD, and the grain boundaries and twins are outlined with corrosion product. Confirmation of the nature of the corrosion product is in progress.

Fig. 56. Photographs of the HYGAS Hinge Pin. Pitting corrosion, galling, and abrasion are visible. The abraded region is shiny.
Neg. No. ANL-306-78-568

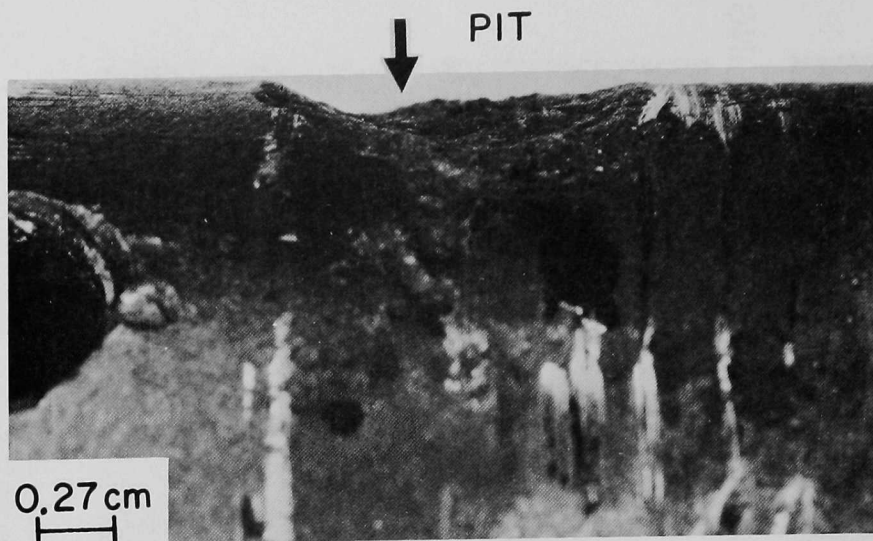
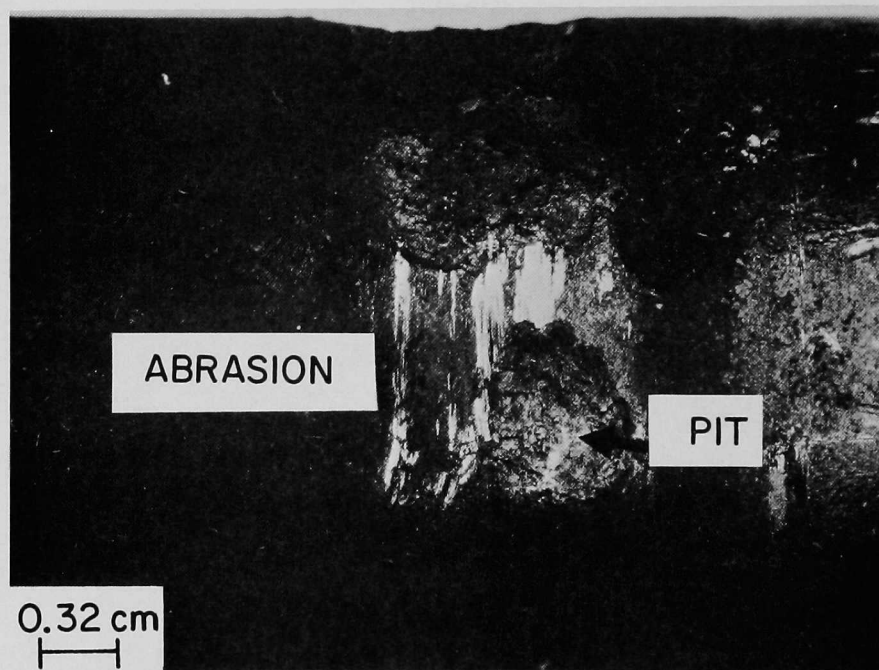
Fig. 57. Photographs of a Pit and An Abraded Region of the HYGAS Hinge Pin. The pit depth is shown in (a); abrasion is visible in (b). The abraded region is shiny, indicating that abrasion occurred after the pits had formed. Neg. No. ANL-306-78-578

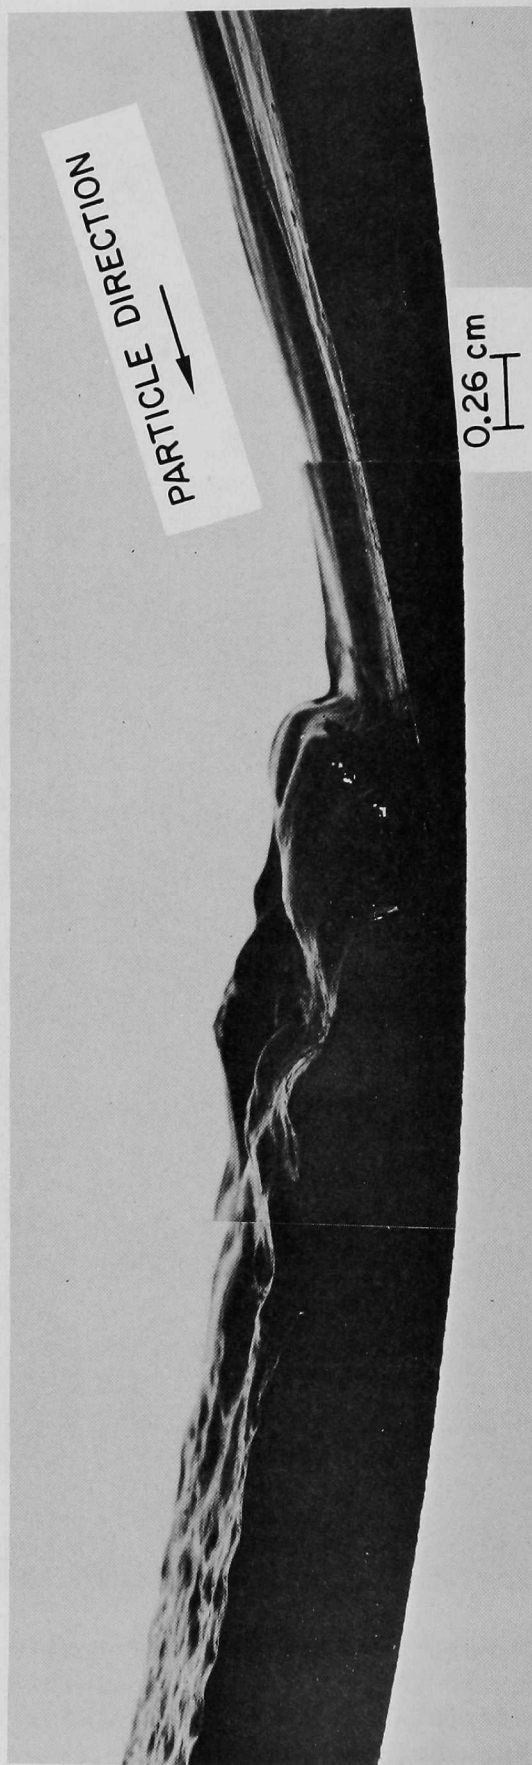
A photograph of the cyclone, showing the particle inlet and the eroded section, is shown in Fig. 59. The perforation occurred at an angle of 20-30° relative to the inlet axis of the cyclone; wall thinning is observed around the perforation. A photograph of the eroded region, as seen through the cyclone inlet, is shown in Fig. 60. The topography of the internal surface appears nonuniform. The eroded regions were sectioned for optical, scanning-electron, and transmission-electron microscopy. A photograph of a polished cross section from the region indicated in Fig. 59 is shown in Fig. 61. The direction of particle impingement is indicated; wall thinning is readily seen.

Fig. 61. Photograph of a Polished Cross Section from the Region Indicated in
Fig. 59. Thinning of the wall is readily seen. ANL Neg. No. 306-78-579

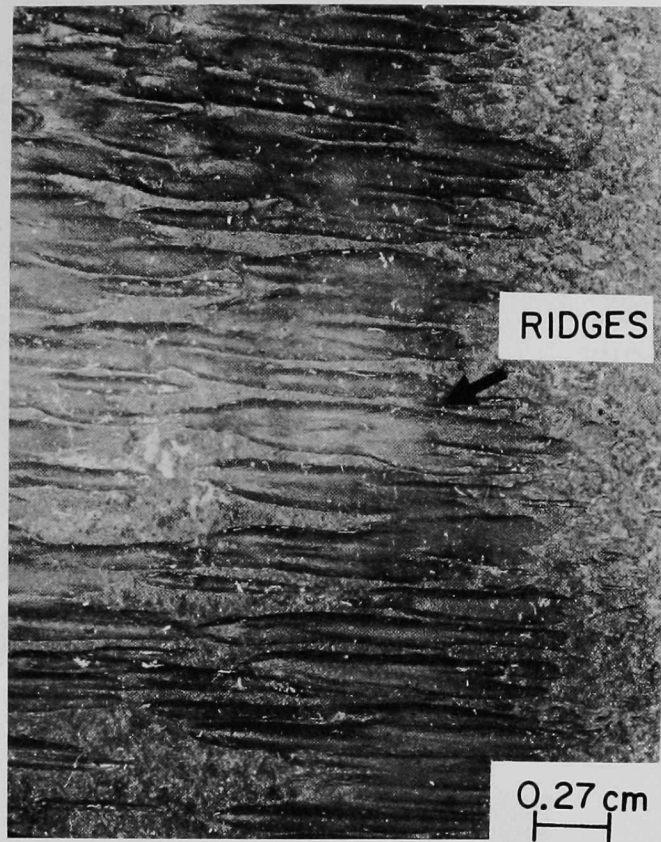
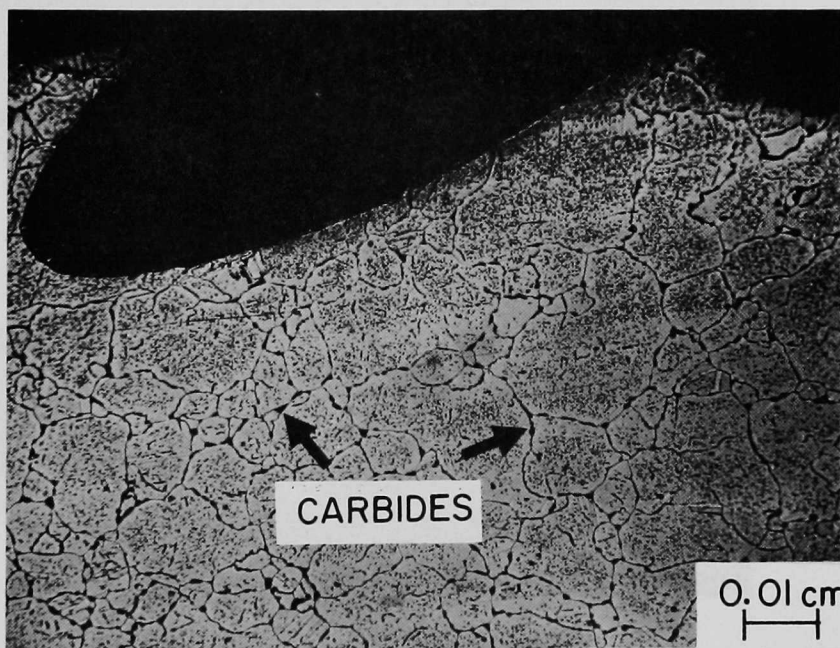
Photographs of the internal surface and a cross section of the polished and etched region are shown in Fig. 62a and b, respectively. Figure 62a shows ridges that have developed as a result of particles plastically deforming the surface. Figure 62b shows a region made hollow by particle impingement and erosion. The micrograph also reveals grain-boundary precipitates. However, the precipitation apparently did not contribute to the failure.

Fig. 62. Photographs of the Internal Surface (a) and a Cross Section (b) of the Cyclone. The ridges in (a) were formed by the impinging particles. The hollow region in (b) was caused by particle bombardment. Sensitization of the steel (carbide precipitation at the grain boundaries) is also visible in (b). ANL Neg. No. 306-78-581

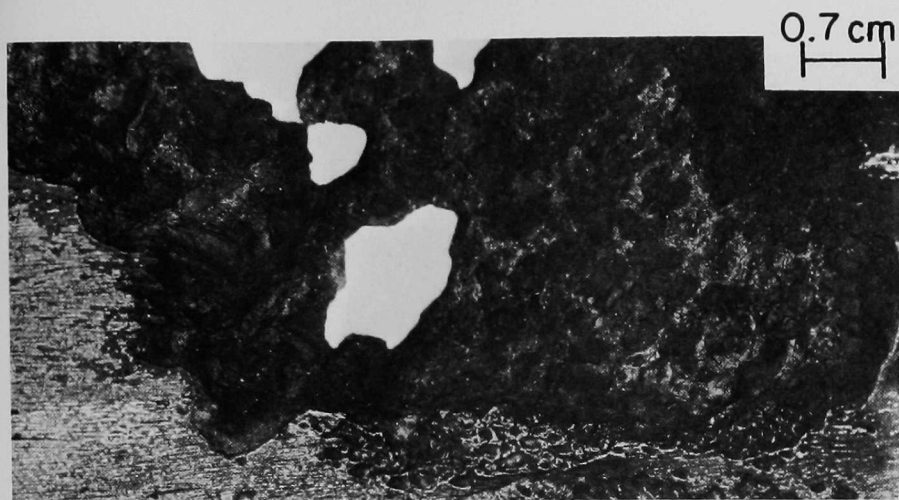
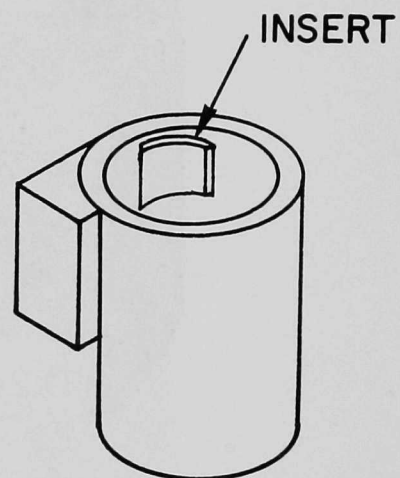
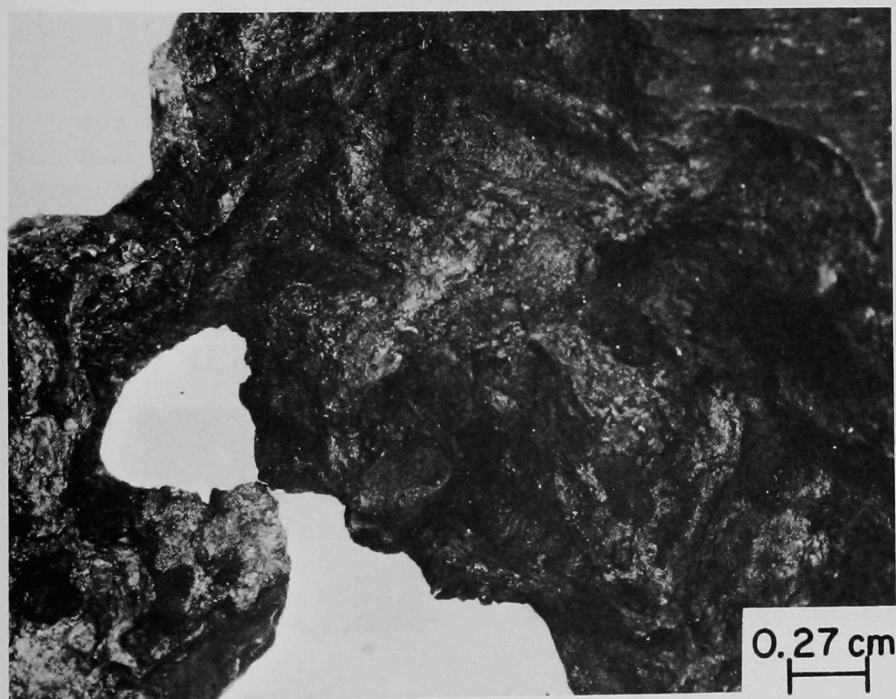
Optical micrographs of the internal surface of the insert, and a schematic of the patched cyclone, are shown in Fig. 64. Perforations and a rough, uneven surface are visible. A cross-sectional view of the weld and insert in the polished and etched condition is shown in Fig. 65. The heat-affected-zone (HAZ) adjacent to the weld can be seen. Particle impingement is from the direction indicated and is reflected in the topography of the internal surface. The weld and HAZ are not as severely eroded as the insert material, as shown in Fig. 66 where the HAZ is observed to be protruding beyond the severely eroded region of the insert material. The grain boundaries of the base material are decorated with precipitates, as shown in Fig. 67; however, the precipitation, which results from heat treatment or operation at high temperatures, did not contribute to the failure.

Fig. 64. Optical Micrographs of the Eroded Stainless Steel Insert and a Schematic of the HYGAS Low-Btu Internal Cyclone. Neg. No. ANL-306-78-573

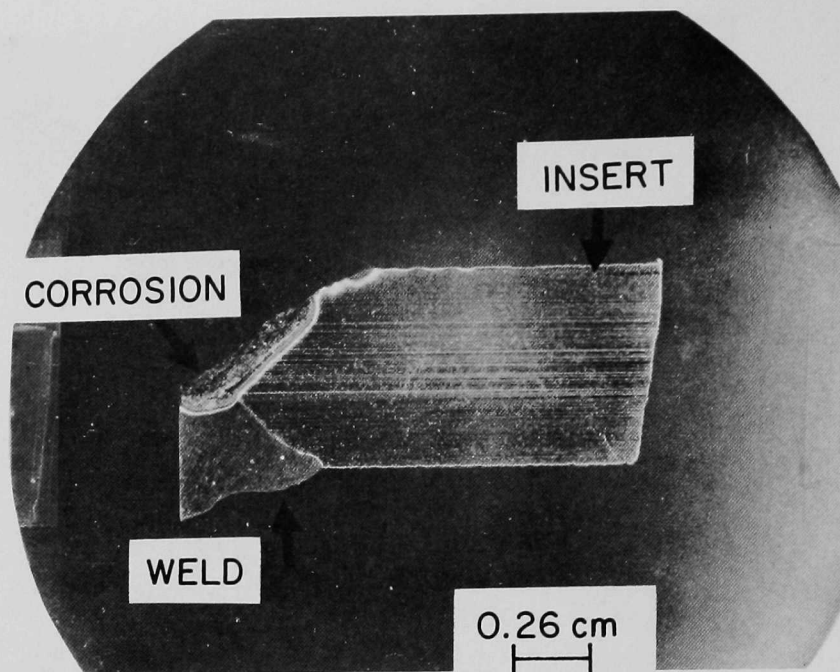
Optical photographs of a portion of the insert are shown in Fig. 69. Figure 69a is an overall view, while (b) and (c) are higher magnifications of two selected areas. The perforations occurred in the weld region (Fig. 69b); surface roughening of the weld is visible in Fig. 69c. A photograph of a polished and etched cross section of the insert is shown in Fig. 70. A heavy corrosion scale is visible at the weld, while the insert is relatively free from corrosion and erosion.

Fig. 70. Photograph of a Polished and Etched Cross Section of the Hard-faced Insert. The weld and insert material are shown. Neg. No. ANL-306-78-587

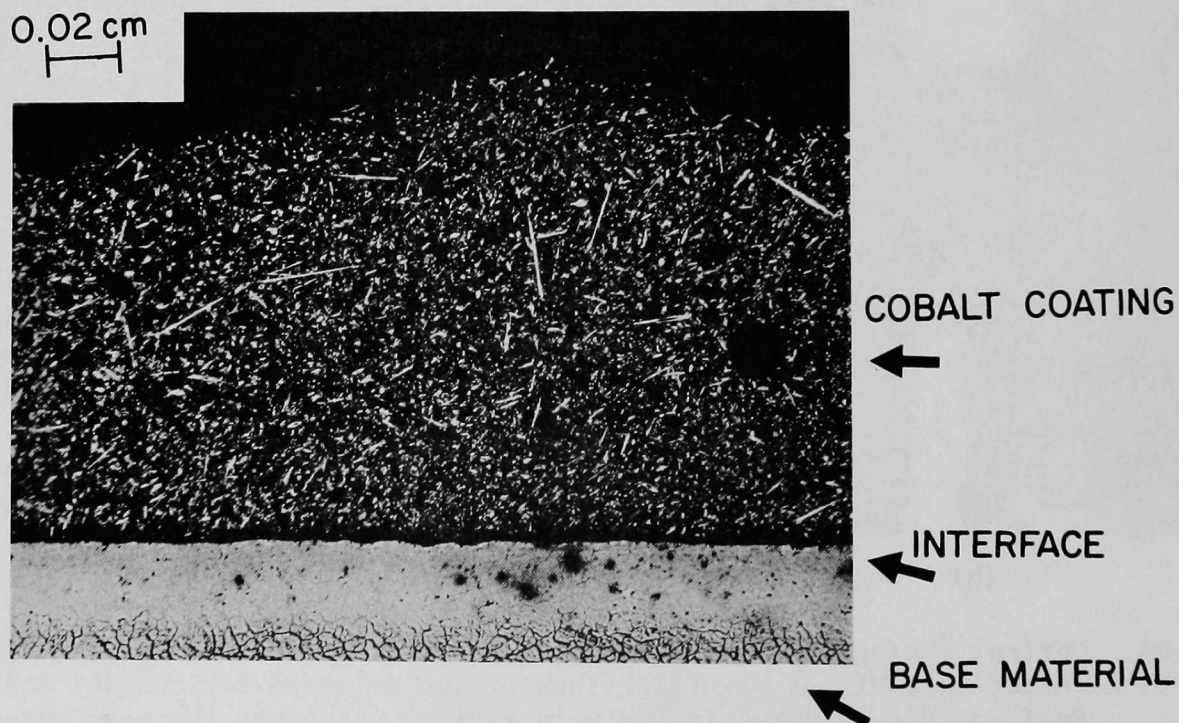
The cobalt hardfacing is shown in cross section in Fig. 71. The microstructure consists of precipitates and a grain-boundary eutectic phase. The interface between the hardfacing and the substrate shows recrystallized base material. A higher-magnification micrograph of the microstructure of the coating and the interface between the coating and substrate is shown in Fig. 72. The microstructure of the coating is similar in appearance to iron-base alloys that contain ferrite and pearlite. Carbides have precipitated to the grain boundaries of the substrate, probably when the hardfacing was deposited. The precipitation did not apparently affect the erosion resistance of the insert.

Fig. 71. Micrograph of a Cross Section of the Cobalt Hardfacing. The microstructure in the coating appears similar to ferrite and pearlite that are formed in iron-based alloys. Neg. No. ANL-306-78-586

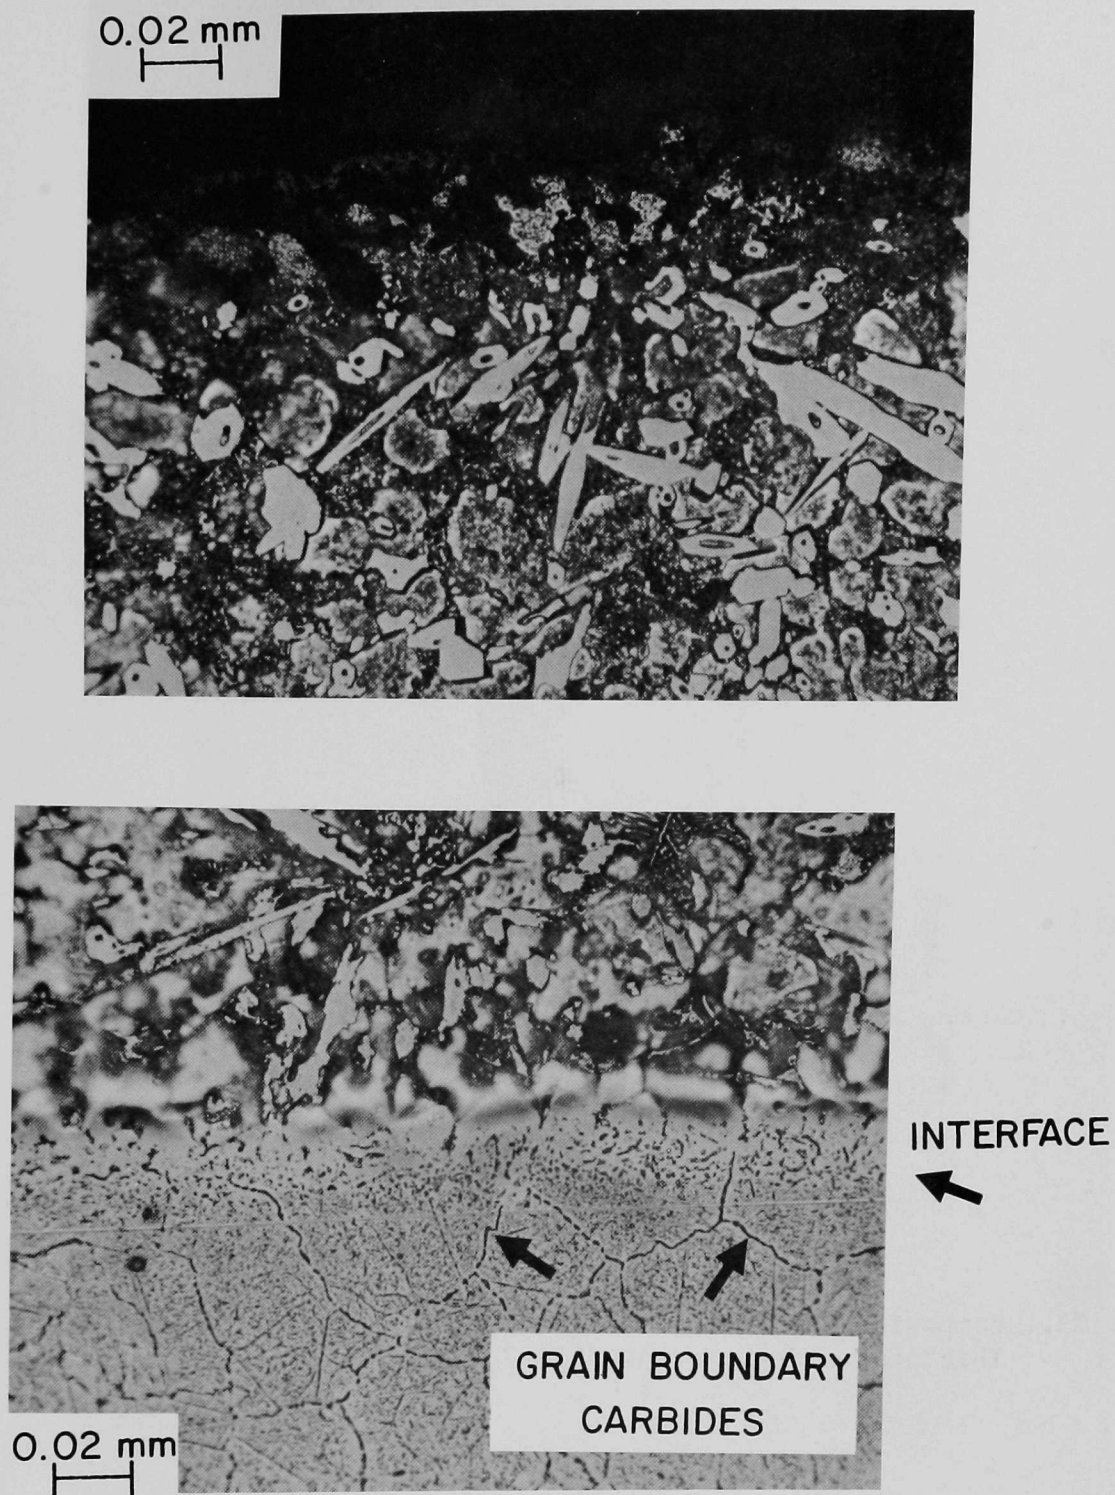
Fig. 72. Microstructure of the Cobalt Hardfacing and the Interface Between the Coating and Substrate. The microstructure in the coating appears similar to ferrite and pearlite that are formed in iron-based alloys. ANL Neg. No. 306-78-584

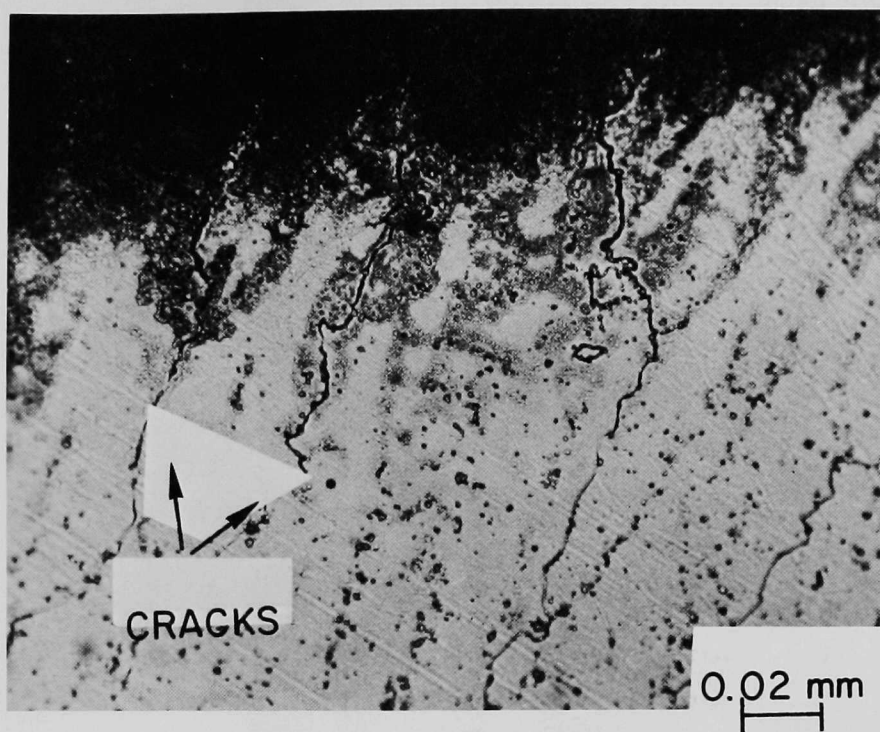
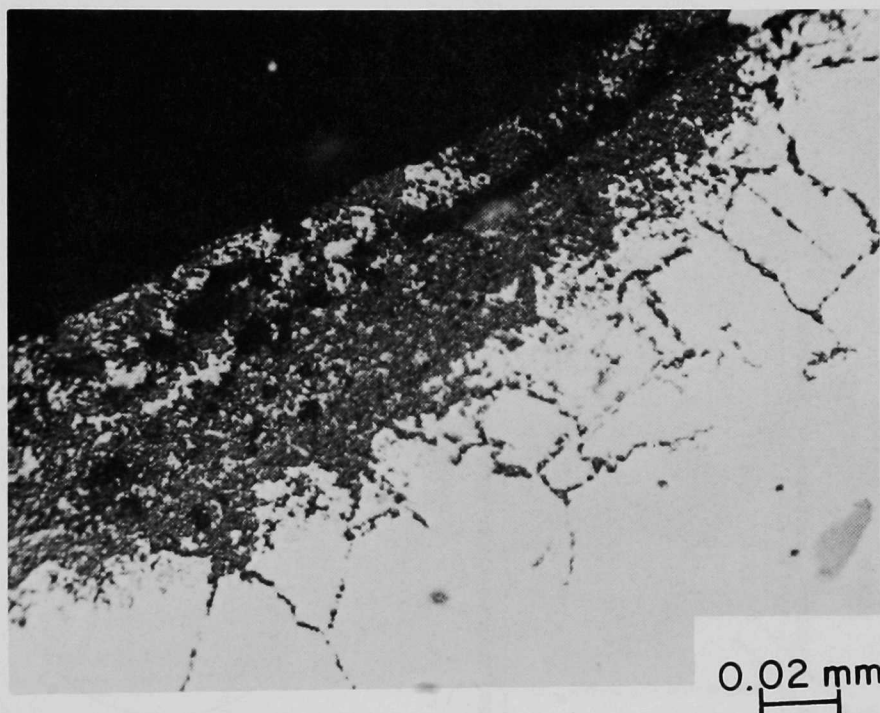
The two micrographs in Fig. 74 show cracking in the base metal near the coating-substrate interface (a) and corrosion and grain-boundary sulfide formation near the weld (b). Both these phenomena will contribute to the degradation of the insert.

Fig. 74. Micrographs of Cracks at the Interface Between the Coating and Substrate (a) and Corrosion and Sulfide Formation Near the Weld Region (b). ANL Neg. No. 306-78-585

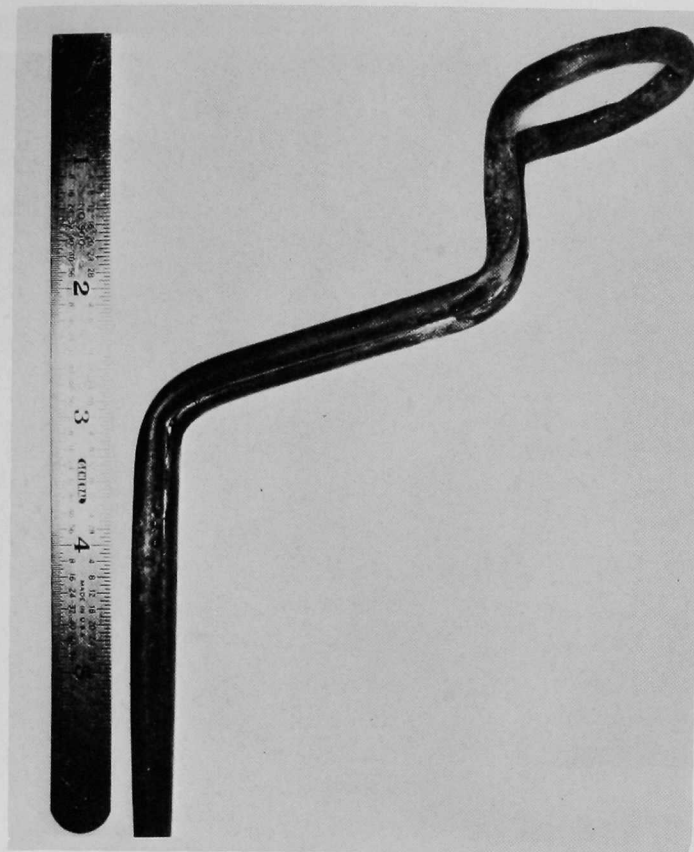
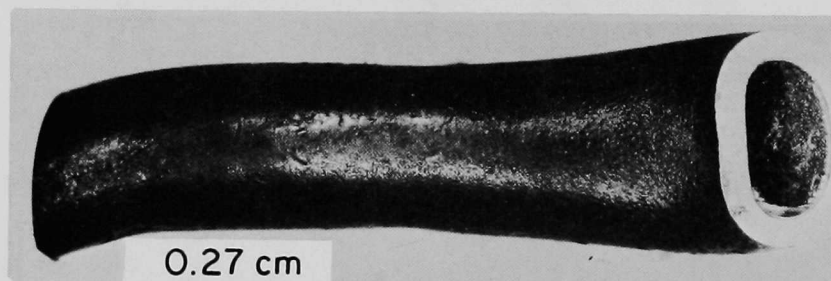
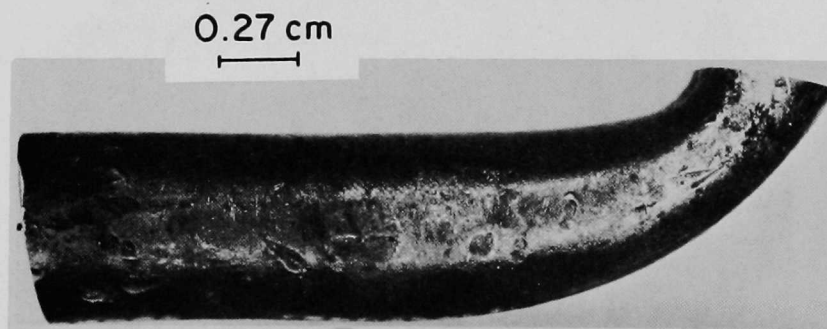
Fig. 76. Optical Photographs of the Taphole Cooling Coil: Overall view (a), Cross-sectional View (b), and Top View (c). The tube ID is out of round, and the outer surface contains many imperfections. ANL Neg. No. 306-78-572

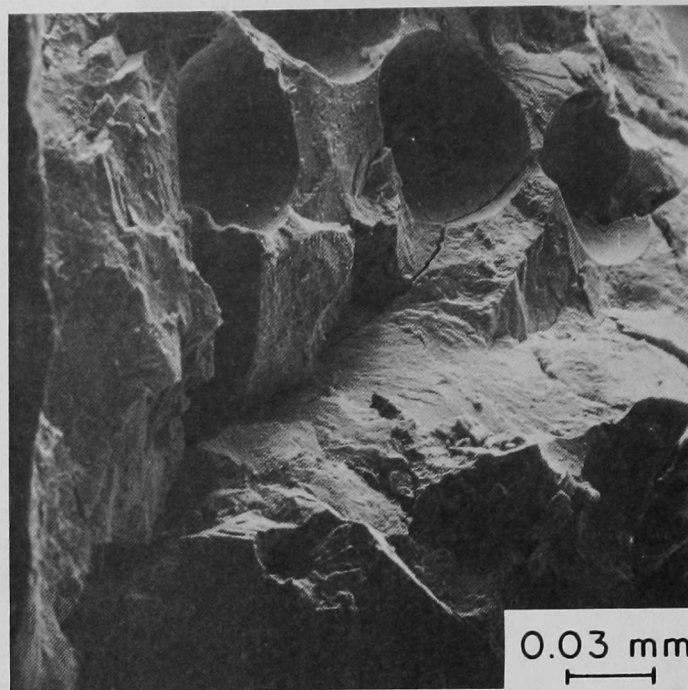
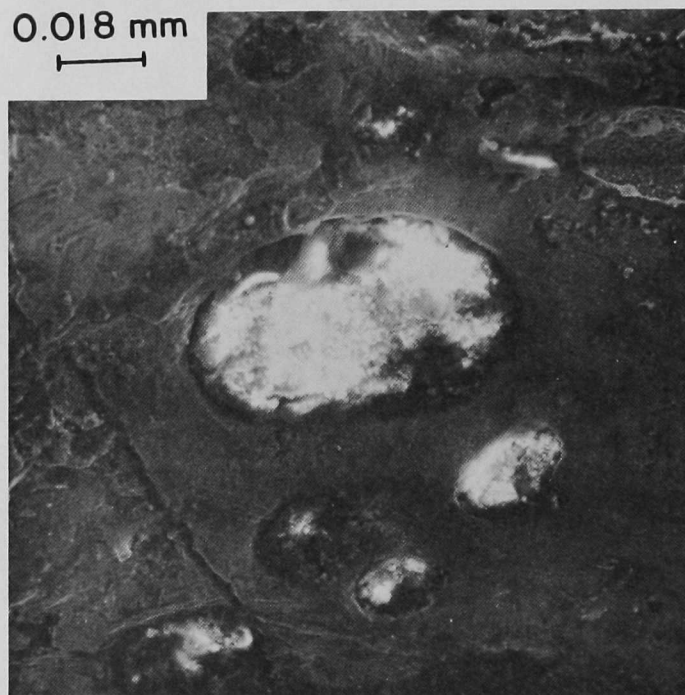
Scanning-electron micrographs of a fracture surface are shown in Fig. 80. The fracture surface in Fig. 80a contains circular depressions along which the crack propagated. These depressions were also visible at the outer surface; Fig. 80b shows several such depressions that contain a nonconducting phase. X-ray fluorescence spectroscopy showed that this phase contained the elements Mg, Si, Ca, S, and Cu.

Fig. 80. Scanning-electron Micrographs of the Fracture Surface (a) and the Outer Surface (b). Circular regions on the fracture surface in (a) contained non-conducting phases as shown in (b). ANL Neg. No. 306-78-571
